CBNS - Rail Infrastructure Evaluation for Service to Novaport Intermodal Facility

Port of Sydney Development Corporation

Hatch Project No. 355011

November 2017

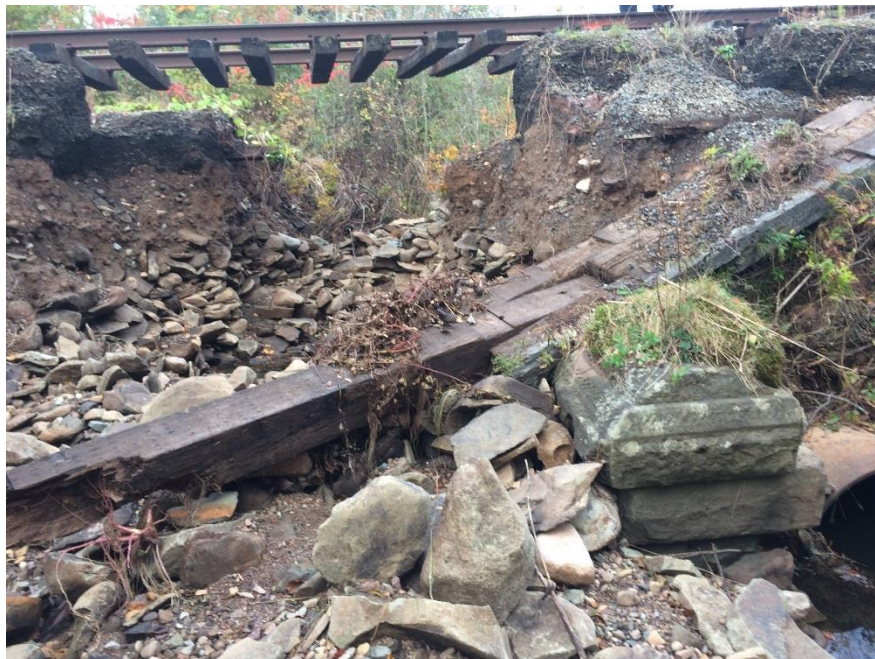
Figure 3: Wash-out and destroyed culvert at mile 110.1.

In addition to the track work defined in the previous section, it is critical that sources of track instability be addressed prior to operating this section of track at even Class 1 speeds. A summary of the data collected during the inspections and the respective costs to rehabilitate these items is provided in Table 4. The total cost estimates for this work are based on the estimated quantity of ballast and rip-rap material required to stabilize the track, as well as the replacement of defective culverts and the re-alignment of track where the supporting rock cliffs have been undermined by erosion.

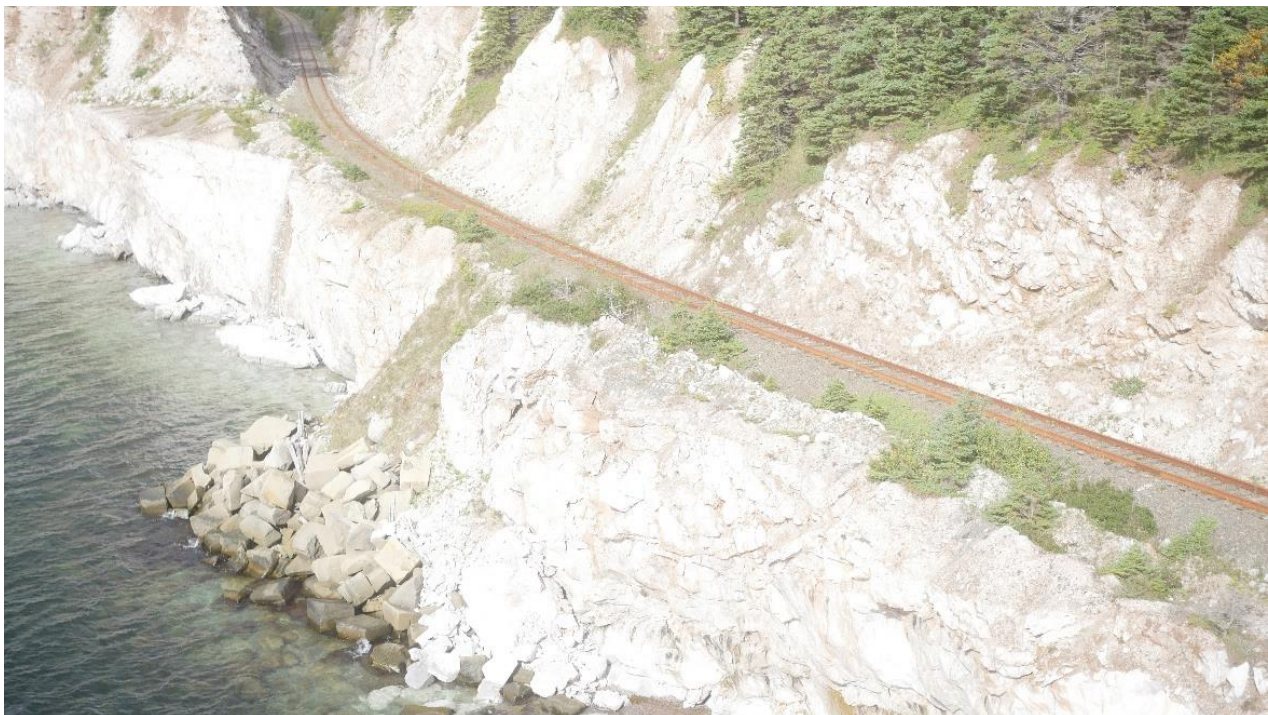
A large portion of the Sydney subdivision runs along the Bras d'Or lakes on cliffs that are composed of very friable rock such as gypsum. In many locations, totalling roughly 1,100 meters, these cliffs have eroded substantially and will eventually undermine the track. 300 meters of this length appear severely deteriorated and would require stabilization prior to trains running at any speed. According to CBNS personnel, the track at these locations has already been moved away from the water as much as possible without requiring major excavation work. Figure 4 shows one of these locations where the track has been shifted and a segment of collapsed cliff was reinforced with armour stone and rip-rap.

Figure 4: Erosion of gypsum cliff supporting track, approx. mile 53.

Estimating the cost of stabilizing these cliff is difficult, largely due to the lack of adequate geotechnical information which would require a full geotechnical investigation, including borehole and sample analysis. Our approach was the following: Two solutions to the instability issue appear reasonable: The armour stone and rip-rap solution, at least short term, has been used successfully in other locations on the Sydney subdivision. This solution may not provide long-term stability, but likely addresses concerns over the short term. A longer term solution consists of a sheet pile wall, protected on the water side with armour stone. This more expensive solution would be expected to provide a longer term protection against erosion. Given the unknowns surrounding the cliff stability issue, a 50% contingency was used in the estimation of both solutions. Table 4 shows the cost associated with the Armour stone and rip-rap solution. The sheet pile solution is tentatively estimated at \$7,200,000.

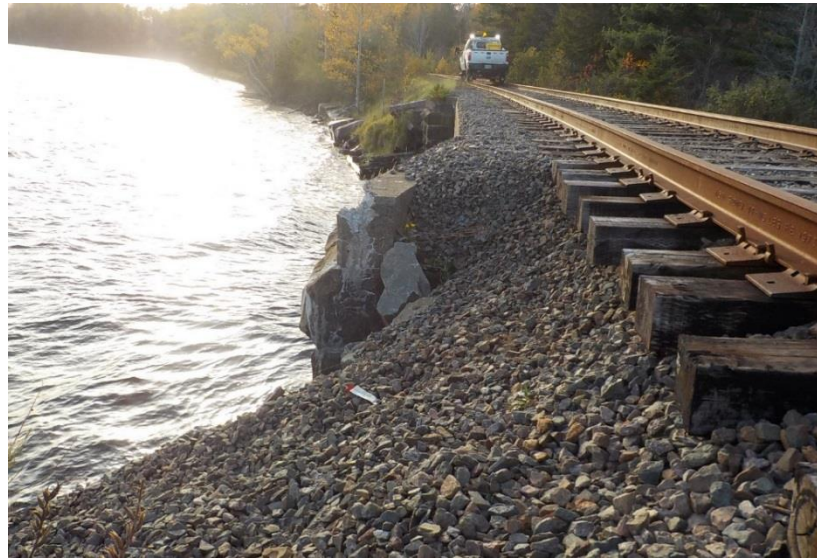
Prior to running any freight traffic on a regular basis the condition of the track at the approaches to the bridge needs to be addressed. It is very common to find low track conditions at bridge approaches since bridge foundation wing walls may limit track maintenance equipment from accessing these areas. In addition, raises in track level over time frequently surpass the intended limits of bridge wing walls and curbs. All the bridges on the Sydney subdivision suffer from a lack of ballast and low approaches varying in severity from minor track shoulder erosion to loss of ballast material beneath track ties. In addition to the common issues noted above,

many of bridges are subject to tidal erosion and waves. Similar to track washouts and bank slides, these areas can cause serious risk to the track stability and cause derailments if not addressed.

Figure 5: Typical erosion and undermining of track support at mile 46.9 Sydney.

The bridge approaches noted above will likely require additional support in the form of gabion walls, pre-cast concrete gravity retaining walls, or steel sheet piles, combined with rip rap in order to stabilize the approaches.

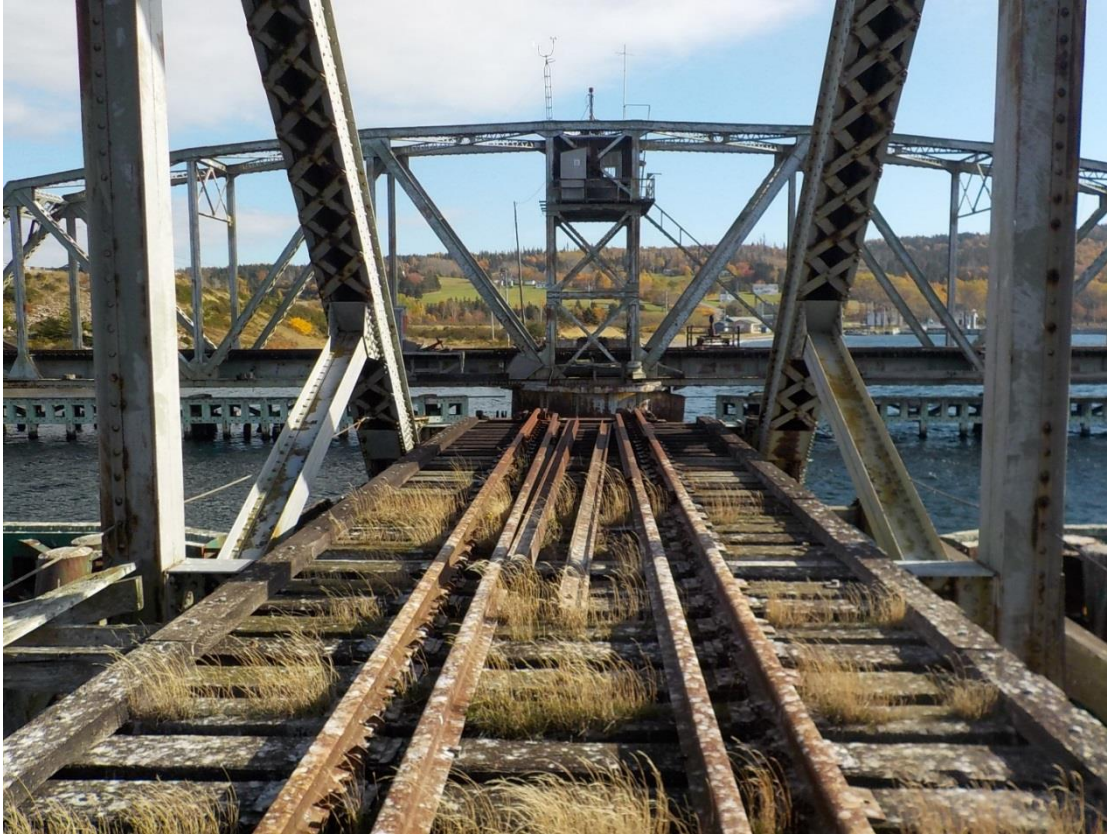
In general most of the bridges spanning a distance greater than 40 feet on the Sydney subdivision are steel structures with open decks, meaning that the bridge ties are principal structural members of the bridges. As such, the condition of the bridge ties has a direct impact on the structure's capacity to support rail traffic. Typically a bridge tie has a lifespan of approximately 30 years when subjected to normal axle loads, however this can vary substantially according to traffic frequency and load. Many of the larger bridges on the Sydney subdivision have substantially deteriorated decks showing advanced signs of rot, splitting and loss of creosote treatment. Deterioration has reached a point that notable vegetation growth was noted in bridge ties at several locations.

Figure 6: Rotten and split ties with significant vegetation at 57.8 Sydney.

The table below summarizes the bridge deck replacements required as part of the immediate work.

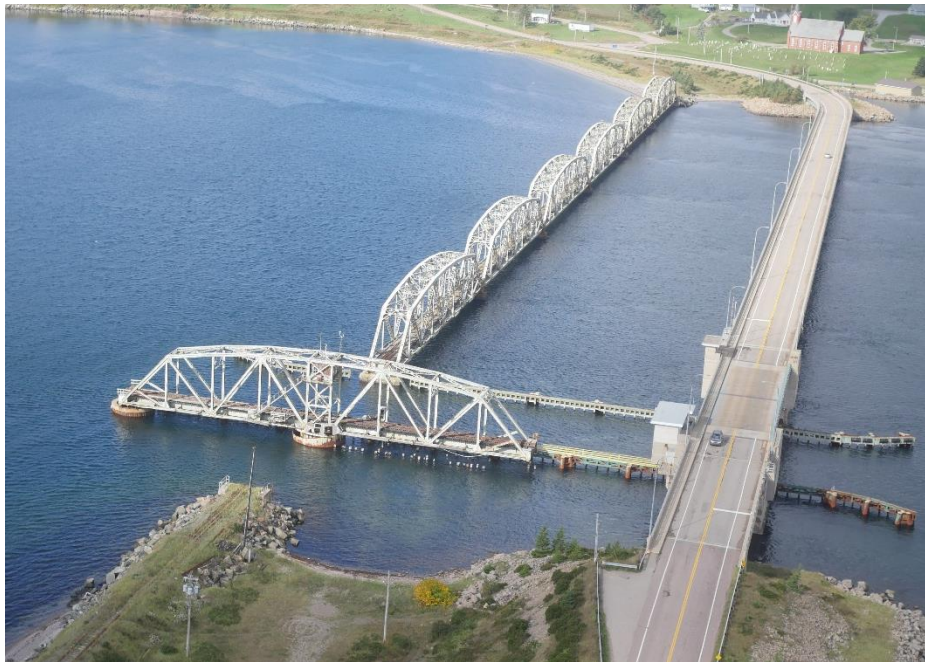
The structures on the Sydney subdivision are generally composed of short concrete spans and moderate sized steel spans, however there are three substantial bridges; the two viaducts at miles 49.4 and 50.7 as well as the through truss swing span at 57.8. The timber decks and main girders on the steel viaducts are substantially deteriorated and will require further analysis and rehabilitation. The swing span at the Grand Narrows bridge (57.8) has not functioned since 2015 and will likely require an electrical and mechanical retrofit if it is to operate on a regular basis. It is possible to pull the swing span open and closed using tug boats, however this is not advisable for regular use given the higher risk of damage. In addition, the locking mechanisms must all be engaged manually and appear to be damaged beyond repair in many cases. Consequently, a complete retrofit of the swing span mechanics is required to operate the bridge under regular rail traffic.

Figure 7: Aerial photo of Grand Narrows Bridge³, mile 57.8.

50.7 Sydney	10 DPG Viaduct	Replace holed lateral bracing system on all spans Replace interior shelf angles on all 60' spans	\$400,000
57.8 Sydney	7 TT + Swing span	Resurface East and West abutments and Pier 7 Modify portal bracing to permit double stack trains Replace stringer bottom flanges throughout Rehabilitate swing span mechanical components Conduct underwater inspection	\$12,400,000

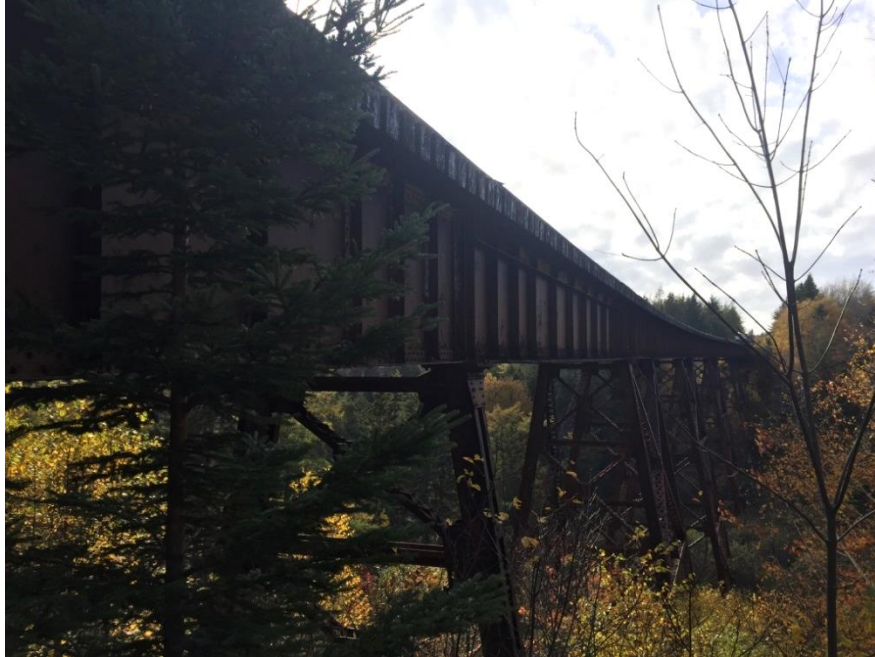
Figure 8: Photo of Walkers Gulch bridge, mile 50.7

49.4 Sydney	11 DPG Viaduct	Replace perforated tower bracing & repair concrete pedestals Repair main girder bottom flanges	\$730,000
50.7 Sydney	10 DPG Viaduct	Replace top lateral braces Repair Tower legs Repair main girder bottom flanges	\$250,000
